October 29, 2021

Tree Assessment – Geyer Road Improvements

Background and Scope: The City of Frontenac is planning updates to Geyer Road south of Clayton Road that include sidewalk installation and storm water improvements. The subject area contains landscape trees that may be impacted by the proposed work. The City requested information about the location, species, size, and condition of trees in the subject area. While there are multiple scenarios of work being discussed (sidewalk location, extent of stormwater work), this report provides a preliminary assessment of trees to the extent requested by the City.

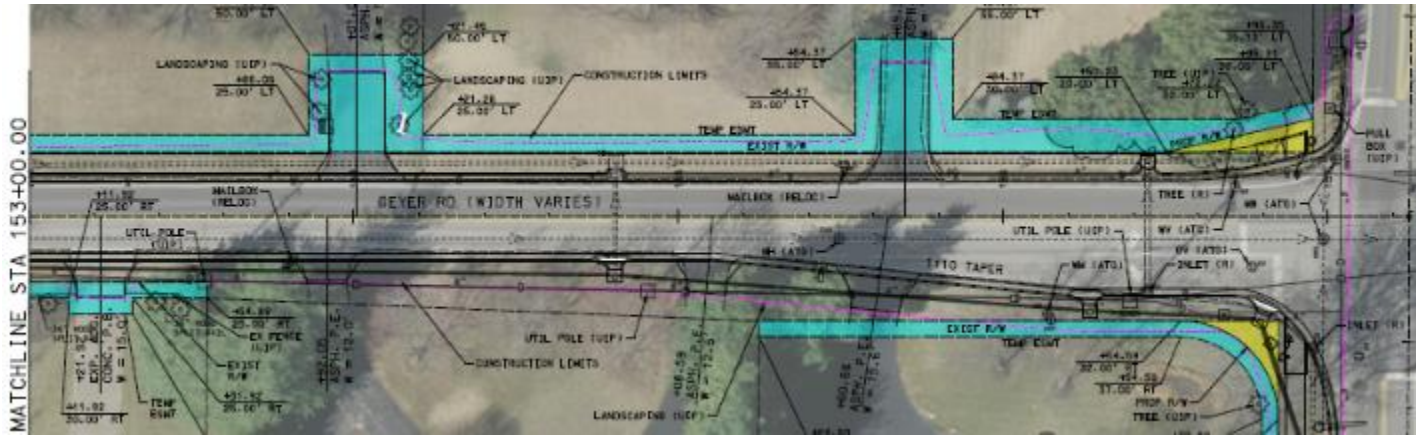
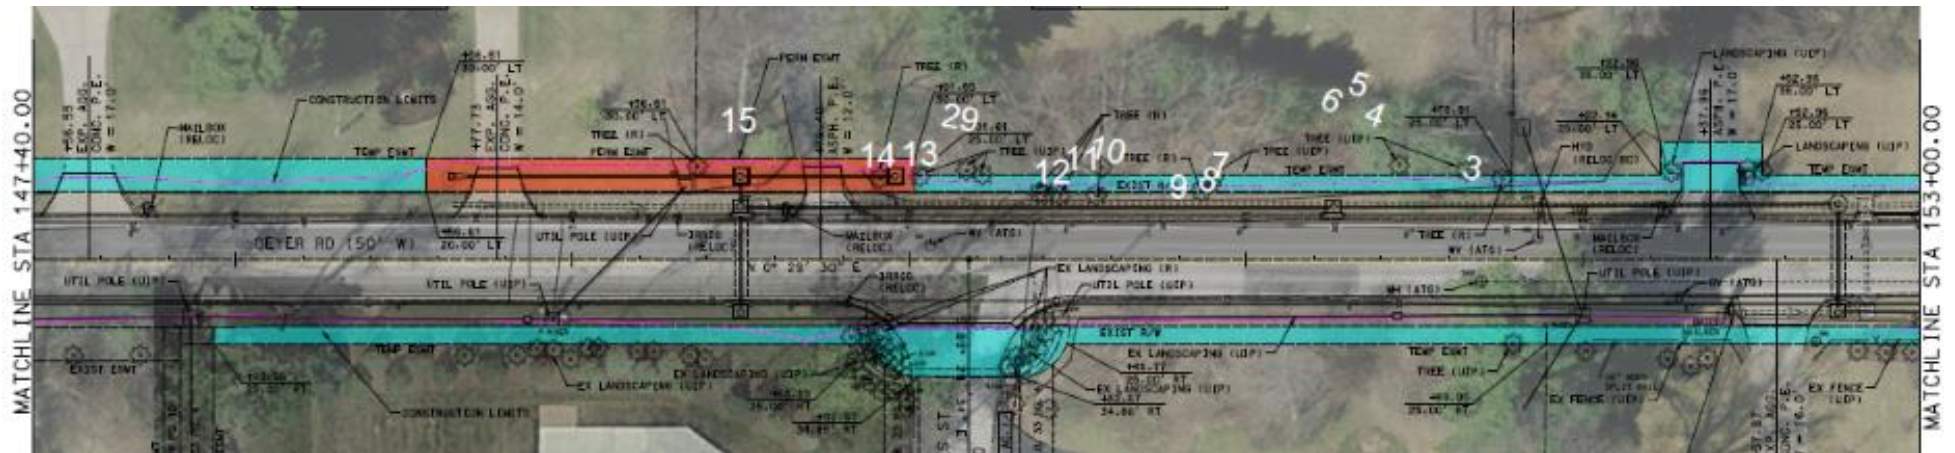
TREE MAP B – West side of Geyer; South of Clayton Road

(Tree numbers added to segments from map produced by Lochmueller Group dated 4-21-2021)

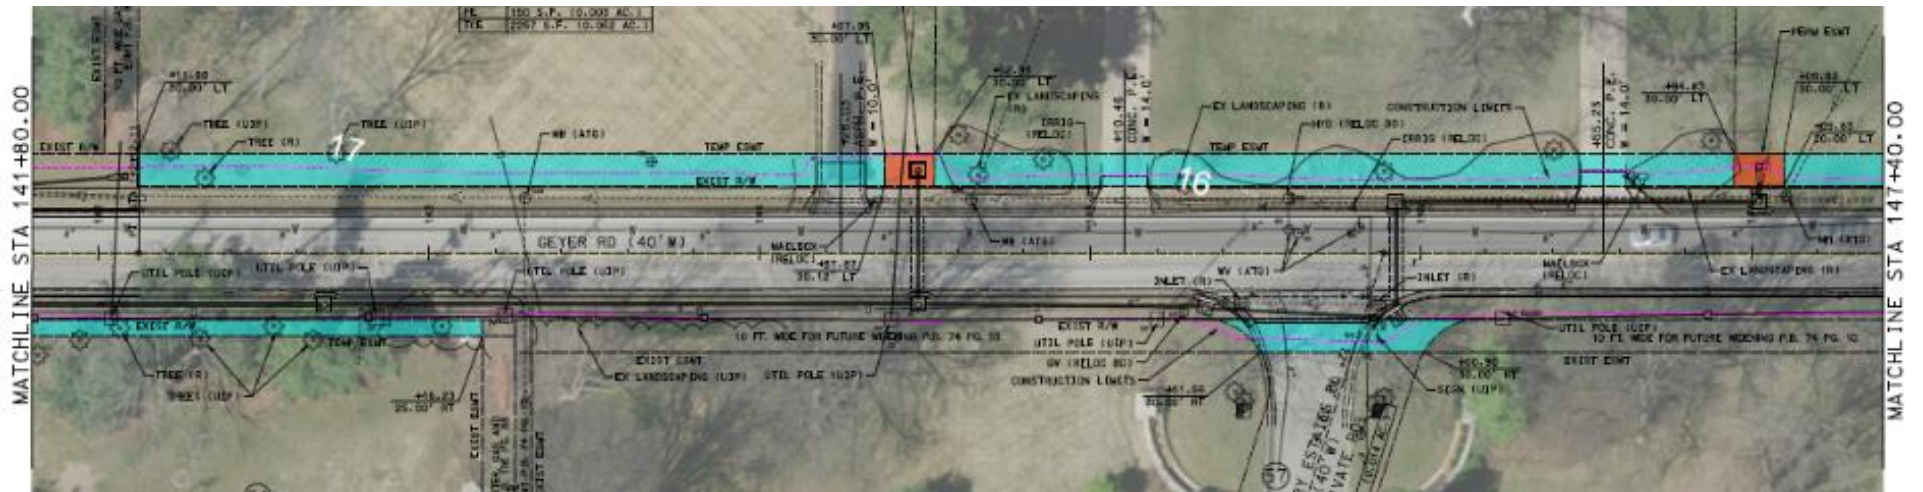
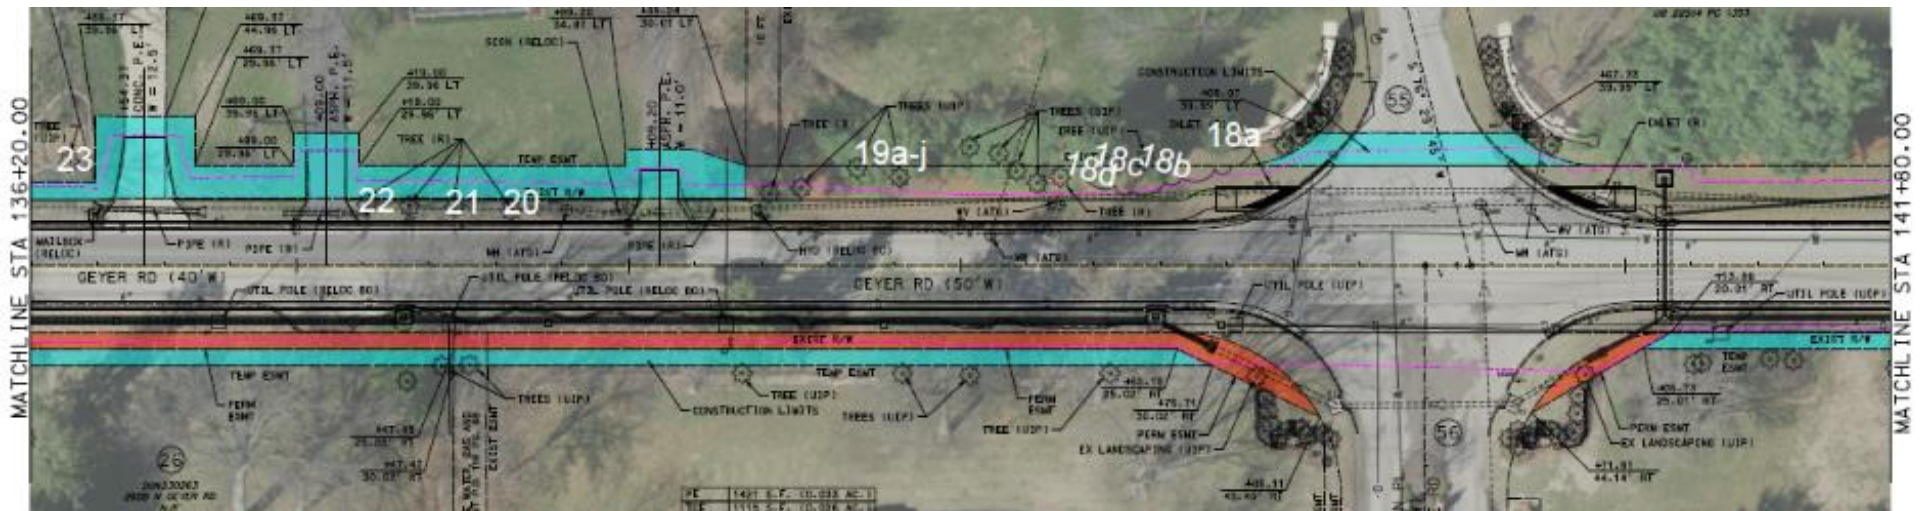
TREE MAP B – West side of Geyer; South of Clayton Road

(Tree numbers added to segments from map produced by Lochmueller Group dated 4-21-2021)

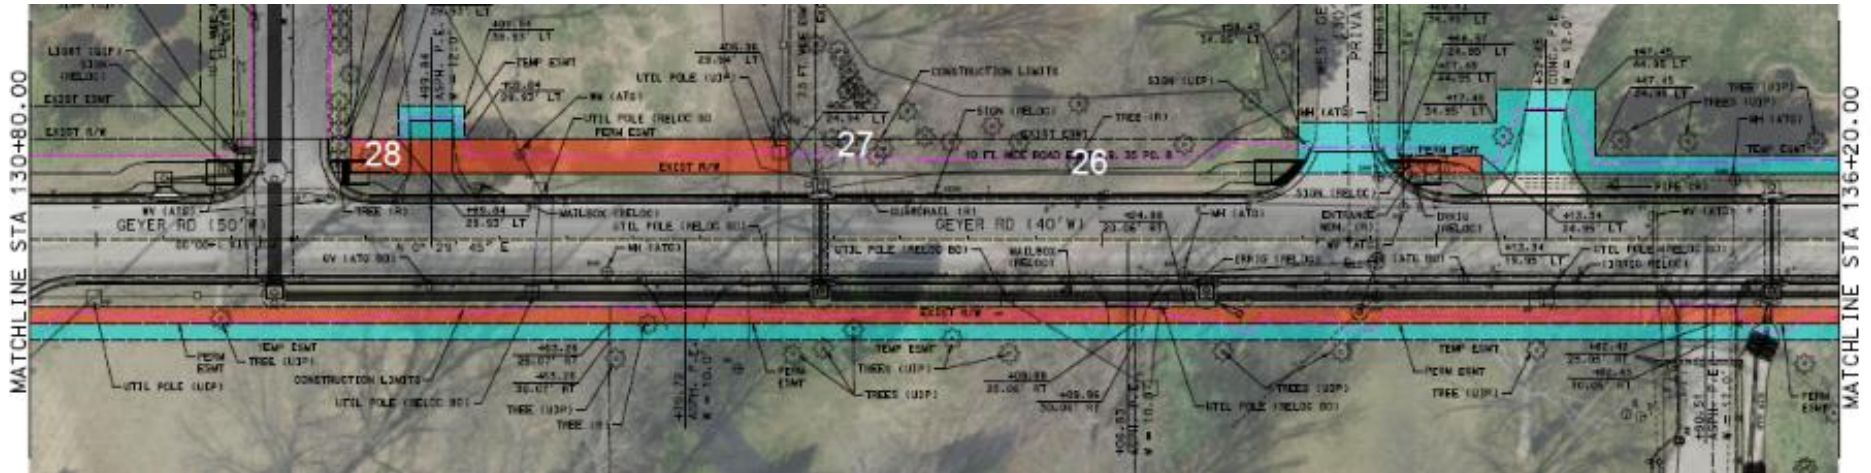
TREE MAP B – West side of Geyer; South of Clayton Road

(Tree numbers added to segments from map produced by Lochmueller Group dated 4-21-2021)
